**EXPANDED SITE INSPECTION REPORT
FOR THE
BENDIX AUTOLITE CORPORATION SITE
(A.K.A. ALLIED SIGNAL)
FOSTORIA, OHIO**

**EXPANDED SITE INSPECTION REPORT
FOR
BENDIX AUTOLITE CORPORATION
1600 NORTH UNION ROAD
FOSTORIA, OHIO**

U.S. EPA Work Assignment No.	:	36-5JZZ
U.S. EPA Region	:	5
Date Prepared	:	February 6, 1996
Contract No.	:	68-W8-0084
PRC Project No.	:	030-0036535
Prepared by	:	PRC Environmental Management, Inc. (Gabriel Rood)
PRC Project Manager	:	Gabriel Rood
Telephone No.	:	(513) 241-0149
U.S. EPA Work Assignment Manager	:	Jeanne Griffin
Telephone No.	:	(312) 886-3007

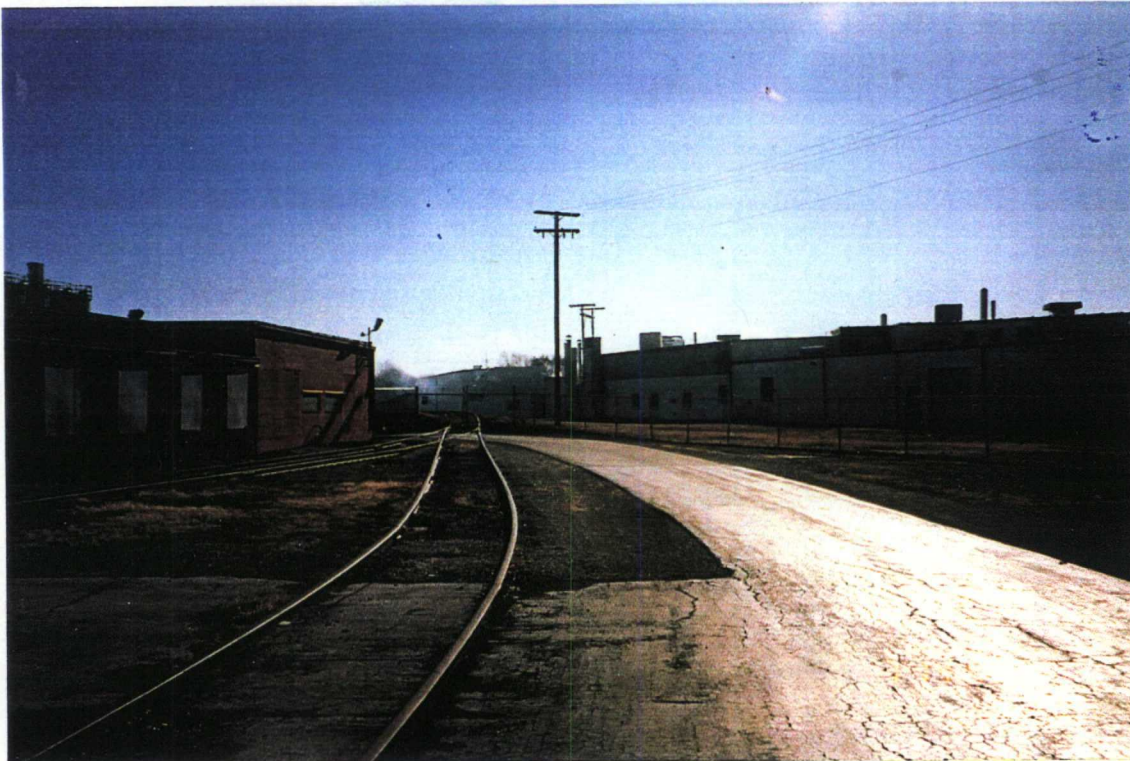
Description: View of RRC building, railroad tracks, Bendix fence, and the transfer station tanks for the former Pearl Oil
